Retrofitting for scale removal

BY JONNY SECCOMBE

Aqua-Rex system

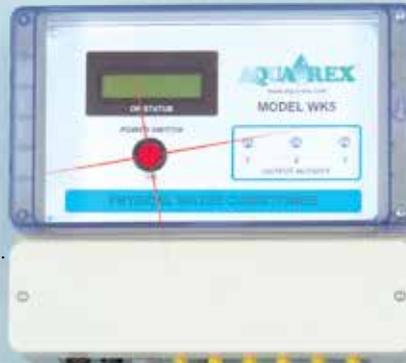
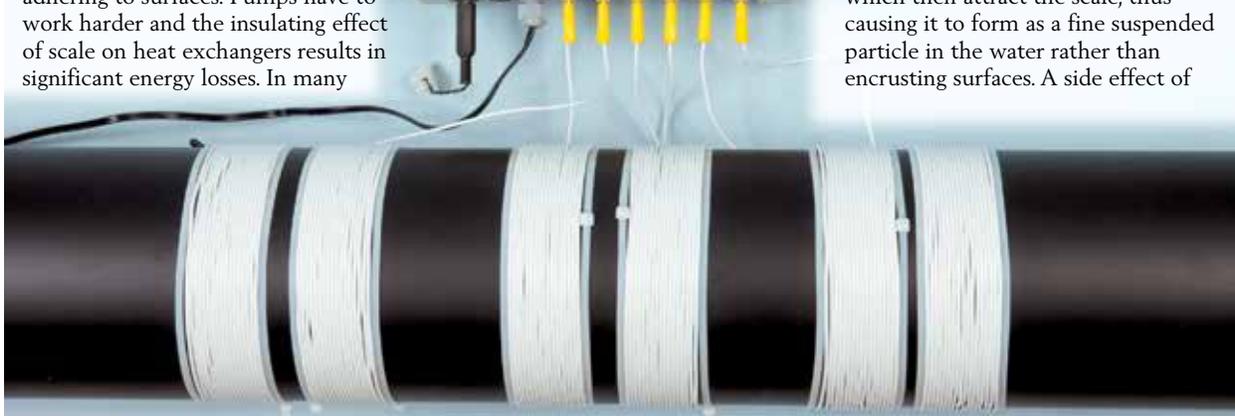
in the U.K. and now commonly used in the U.S., was installed upstream of the valve. The technology uses a radio transmitter to generate ultra high frequencies that are transmitted into the water by pairs of antenna wrapped externally around a water pipe. These radio signals cause nucleation seeds to form in the water, which then attract the scale, thus causing it to form as a fine suspended particle in the water rather than encrusting surfaces. A side effect of

this process is to cause the existing scale to break away from the surface where it has been attached. It literally de-laminates or exfoliates from an encrusted pipe or surface.

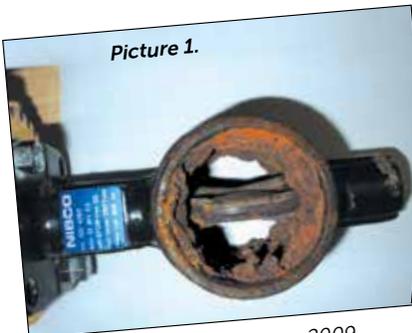
Picture 1.

In this photo taken in February 2009, turbulence has induced low pressure zones, and scale has originally formed around this butterfly valve, rendering it inoperable.

Picture 1 shows a typical inoperable butterfly valve in the hot water supply. The valve is inoperable and jammed in the open position. The scale has originally formed around the valve due to turbulence that has induced low pressure zones around the valve body. Scale precipitates when water is heated or pressure is reduced such as in turbulent flow.

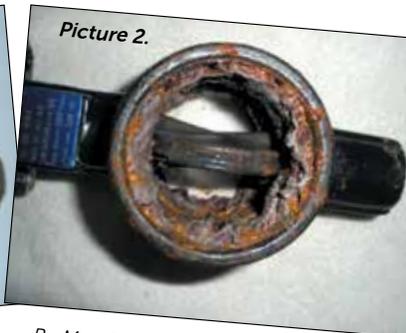
Picture 2.

By May 2009 the scale has changed character and a faint line is developing between the scale and the inside body of the valve, showing that the de-laminating process is beginning.

After seven weeks, the valve was removed for inspection. Picture 2 shows that the scale has changed character and a faint line can also be seen developing between the scale and the inside body of the valve illustrating the de-laminating process that is beginning. Some of the scale has clearly broken away but none of it was retained in the strainer. The valve was still inoperable. The valve was replaced in the line and the trial continued.

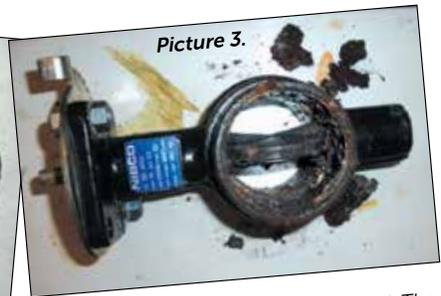
Picture 3.

Most of the scale is gone by June 2009. The final pieces fell out during handling, and the valve became fully operational again. This particular type of scale, common in Las Vegas, breaks down into a very fine powder and passes through strainers causing no associated problems.

After another four weeks, the valve was pulled again, and Picture 3 shows that most of the scale had fallen out. During handling, the final

pieces fell out and the valve became fully operational again. Inspection of the strainer revealed that none of the scale had been retained. It appears that this particular type of scale, common in Las Vegas, breaks down into a very fine powder and passes through strainers causing no associated problems.
