TRIAL OF AQUA-REX AT 2,700 ROOM RESORT HOTEL & CASINO ON THE LAS VEGAS STRIP

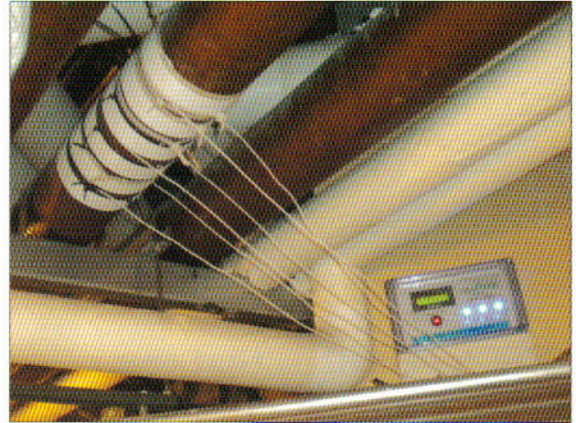
This picture shows the Aqua-Rex WK5 which was installed on a 6" cold riser after the booster set in the ground floor plant room. Photographs were taken of the shower heads in a selection of rooms on December 30th 2010 and show chrome rings with encrusted scale that would normally only be removed by acid cleaning. The same rooms were visited on January 26th 2011. The shower rings were removed and wiped with a soft cloth. The remaining scale was then rubbed with a plastic abrasive cleaning pad. Whereas previously the surface scale was impossible to remove with anything other than acid, it was now possible to wipe away more than 90% of it with a soft cloth. The pictures reproduced below show the shower heads from each room. The pictures on the left were taken in December and those on the right in January. The room numbers are shown in the top left corner.

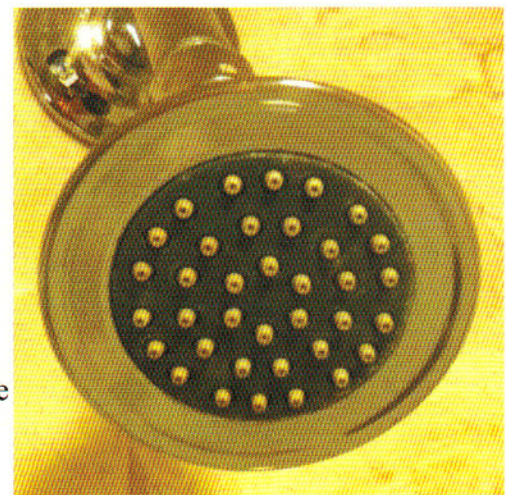
Room 32020 shower head on March 29th 2011. Compare this picture with the original shower head taken on December 30th 2010.

On 29th March 2011 the hotel occupancy was very high and we were only able to inspect the shower head in 32020. Pictures were taken of the chrome ring in the condition it was taken off the head. A picture was taken again after wiping with a soft towel and removing a little scale with the thumb nail. The results showed that the ring cleaned up completely as it had done on January 26th, two months earlier.
