Cooling Tower Case Study in Merida, Mexico
Project: Fernandez Chicken Farm

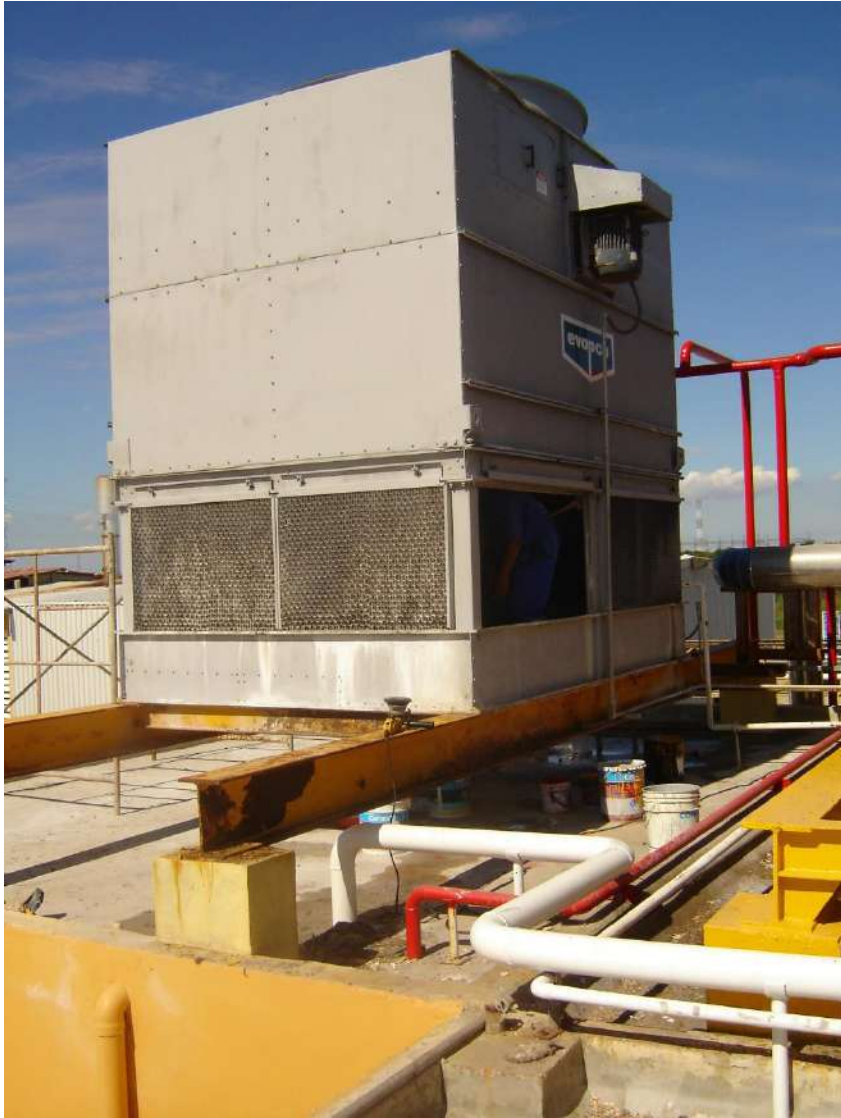
INITIAL STATUS:

Cooling tower located on roof of chicken structure

Running inefficiently due to scale build up on cooling panels and tubes

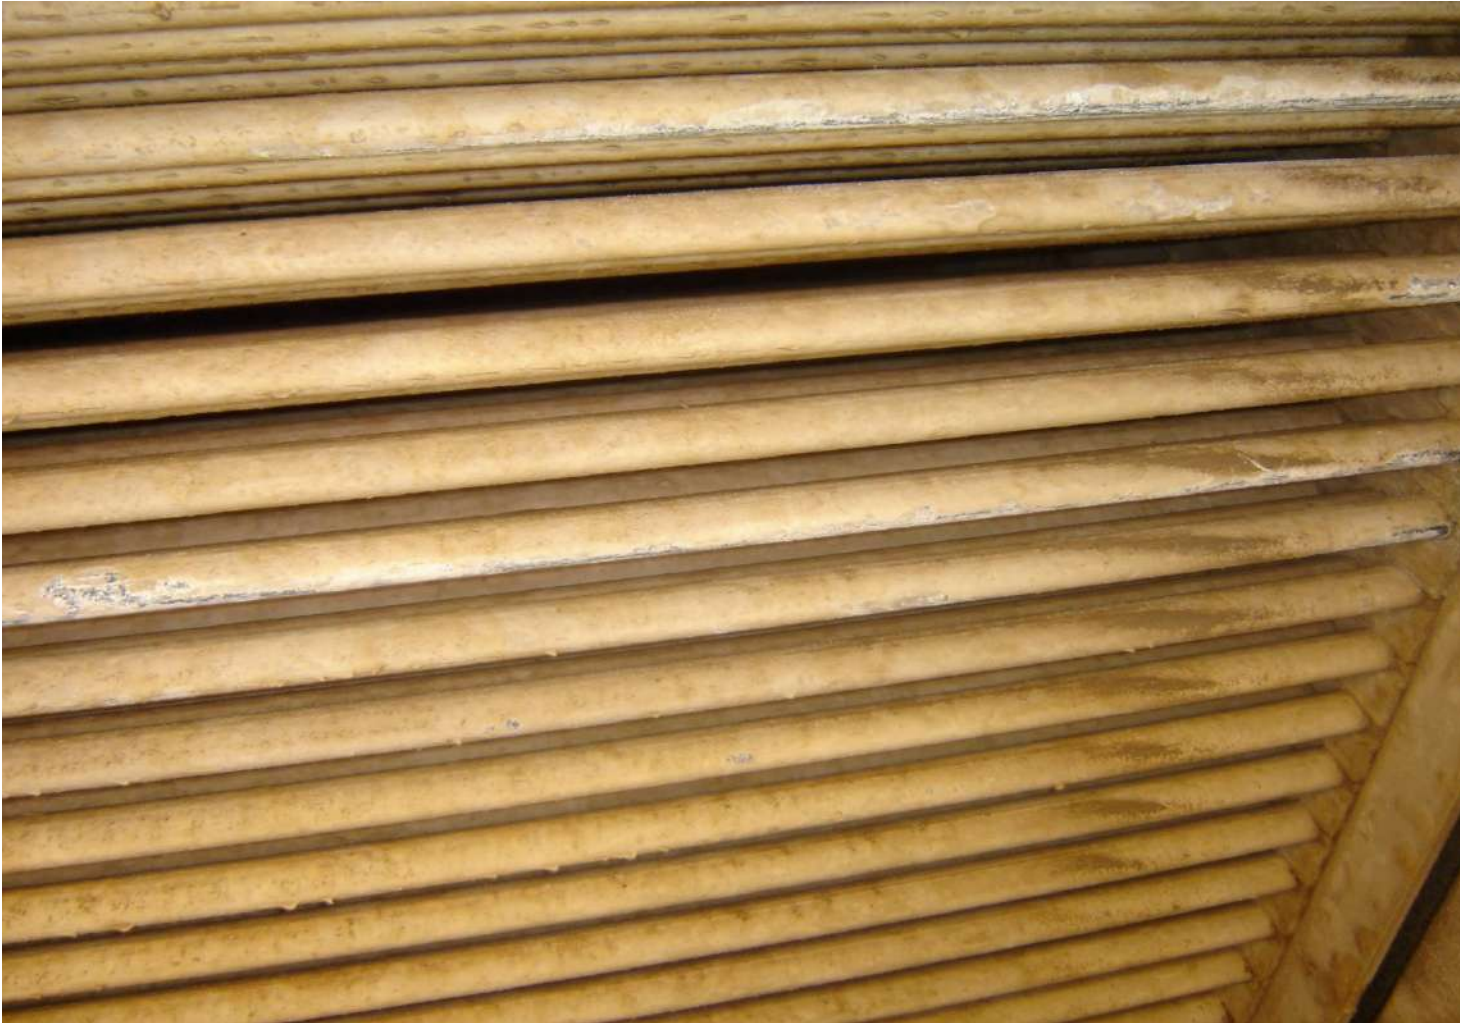
INITIAL STATUS DETAIL

Prior to Aqua-Rex treatment

Tubes encrusted with scale

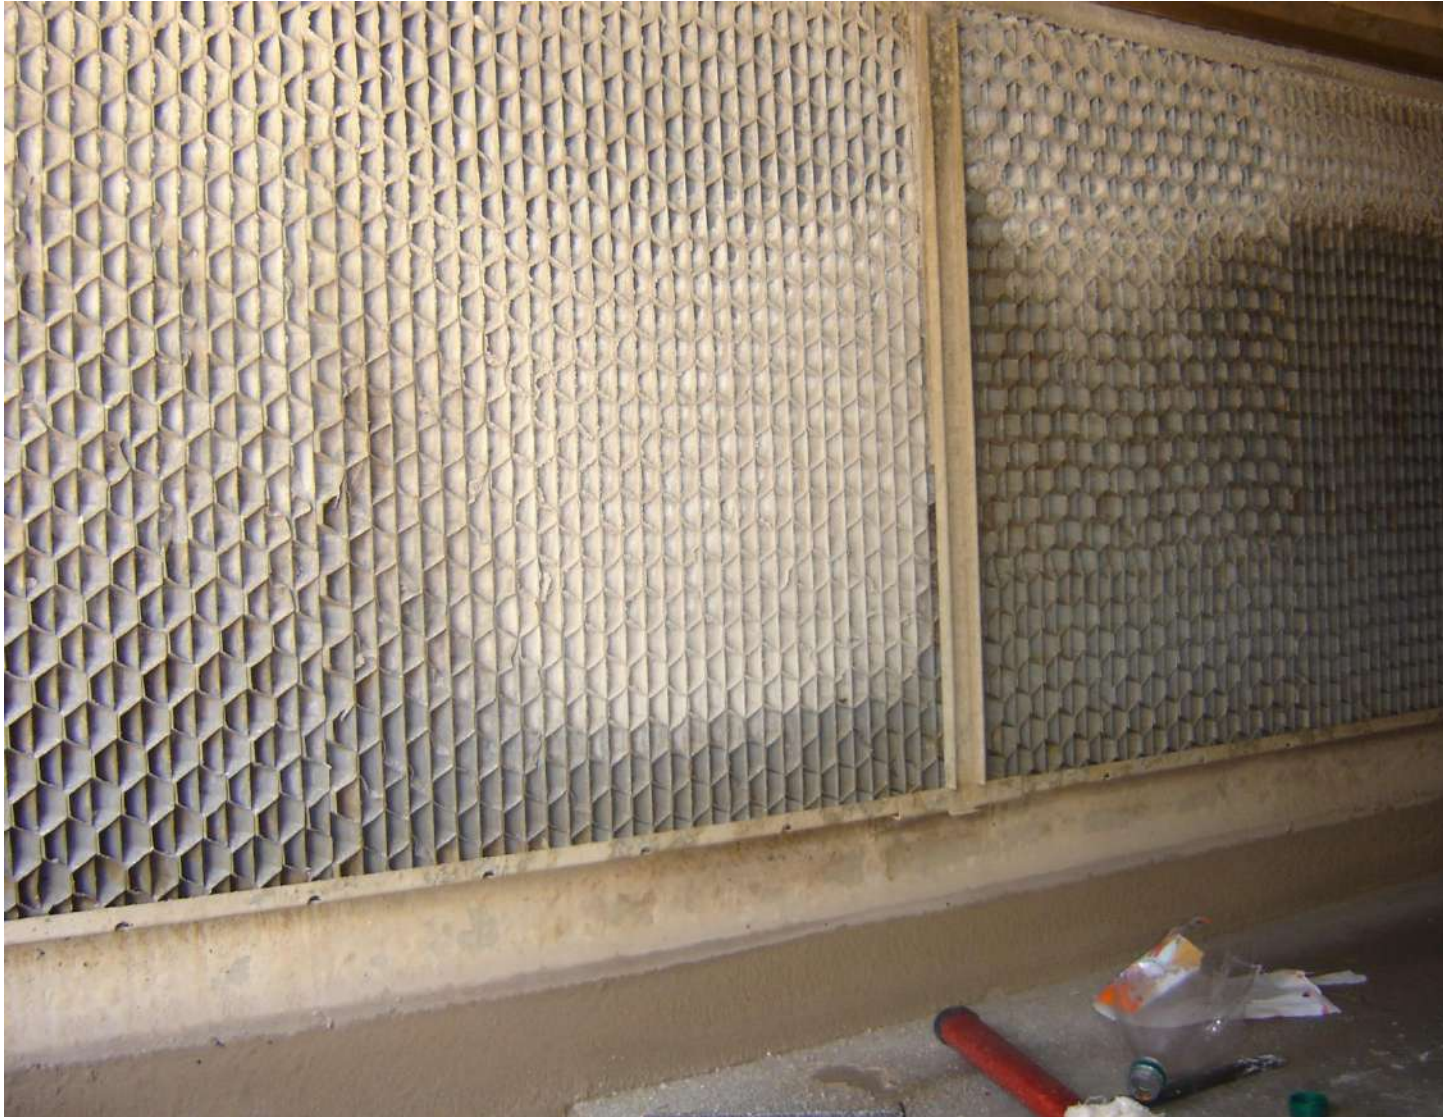
INITIAL STATUS DETAIL

Prior to Aqua-Rex treatment

Cooling panel encrusted with scale

It was determined that the system required an Aqua-Rex WK6 on the distribution system immediately before the nozzles

Control sections of the tubes and cooling panels would be cleared of scale to show that no new scale would accumulate

Sections already encrusted with scale would be used to demonstrate the effectiveness of Aqua-Rex at removing existing scale

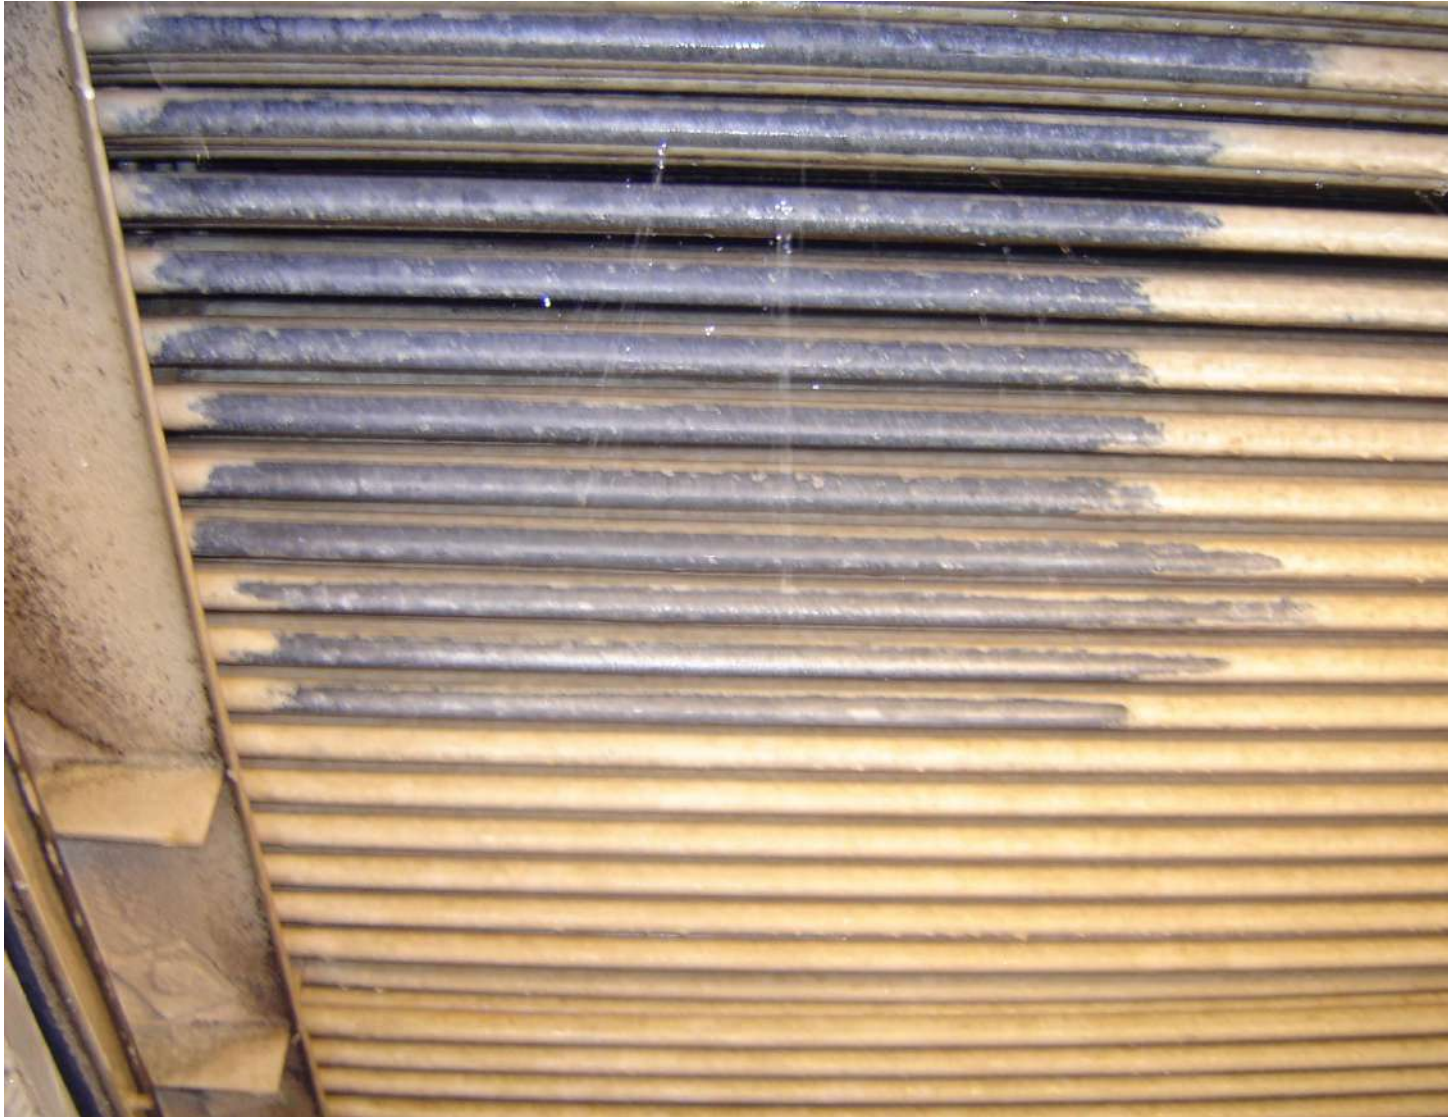
CONTROL SECTION DETAIL

Day 1 of Aqua-Rex treatment

Control section of tubes cleaned on
small section at beginning of
treatment

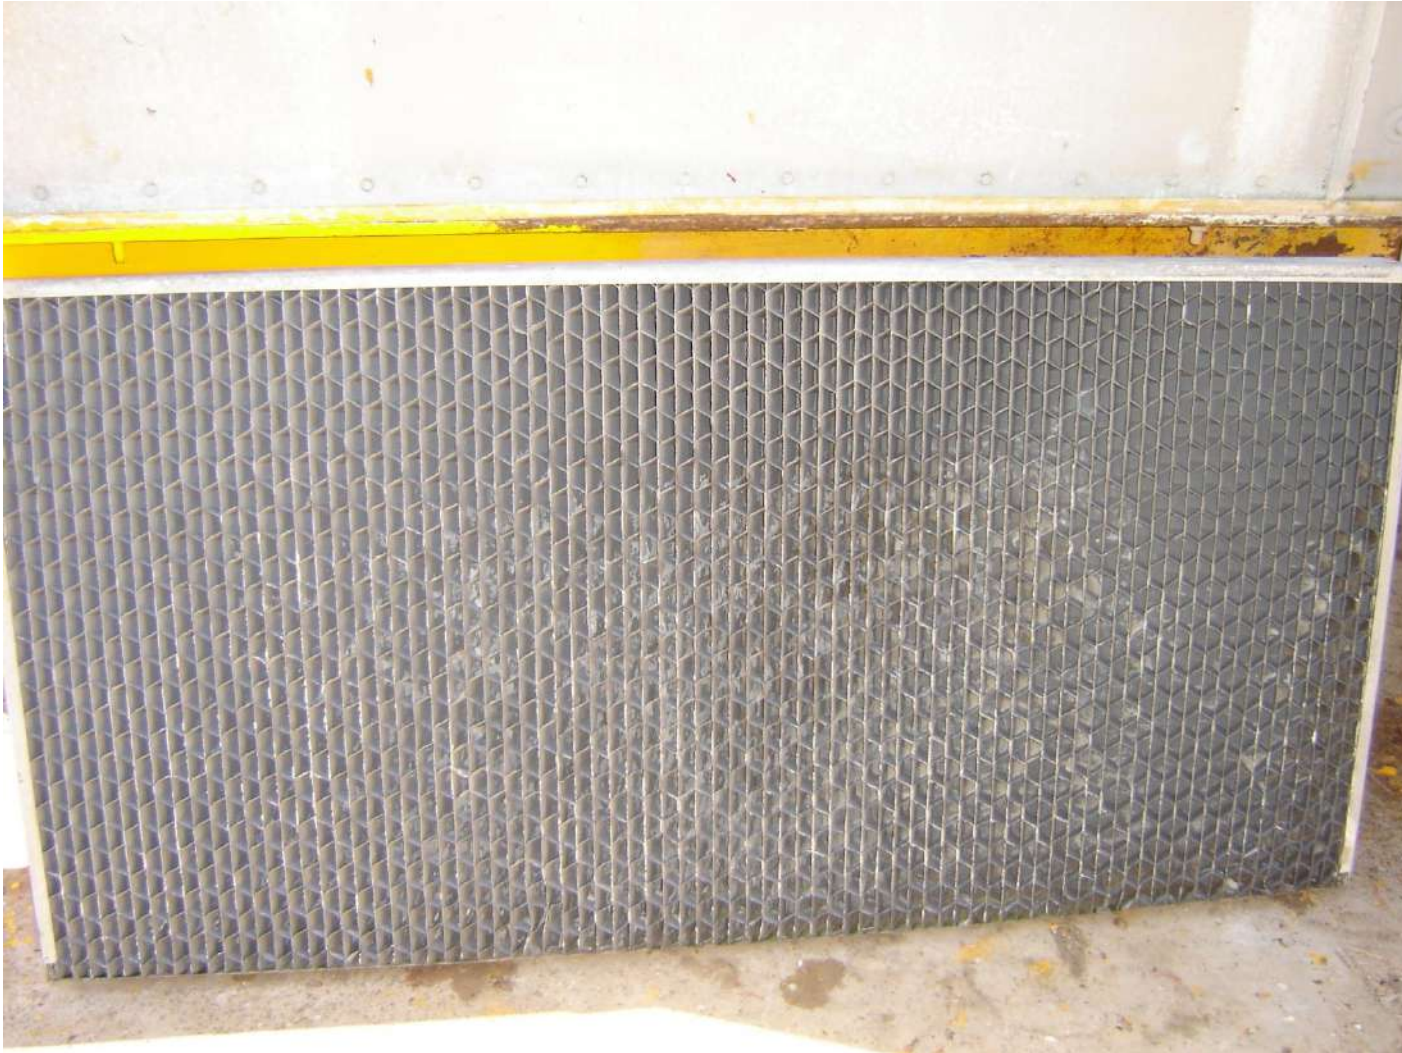
CONTROL SECTION DETAIL

Day 1 of Aqua-Rex treatment

Section of cooling panel cleaned at
beginning of treatment

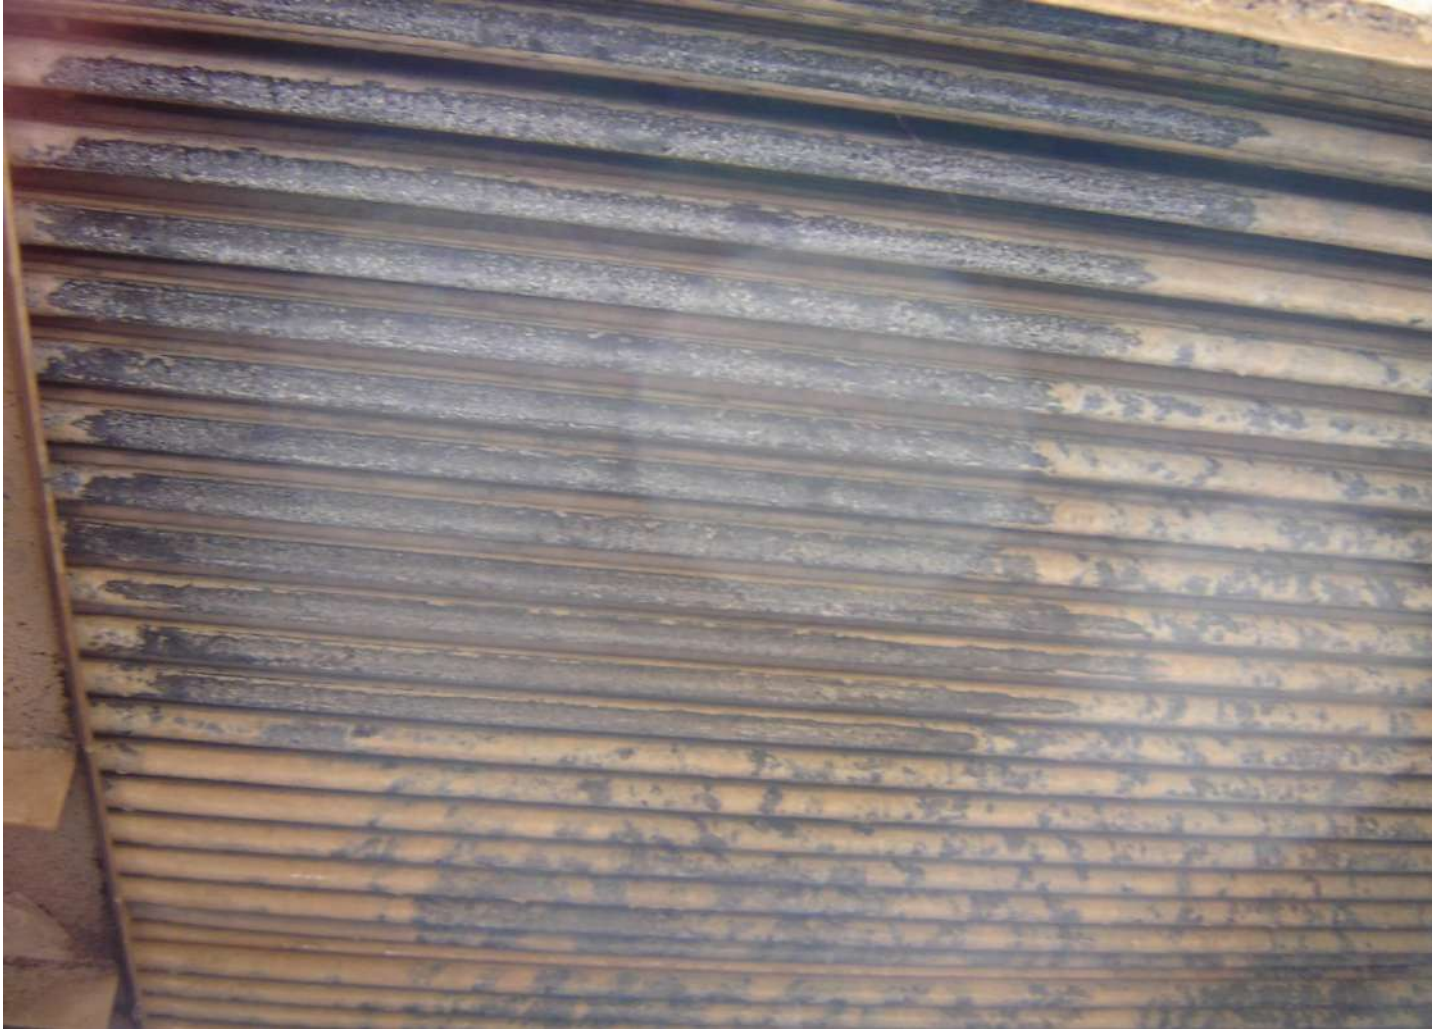
RESULTS DETAIL

Day 62 of Aqua-Rex treatment

Cleaned control section on tubes
remains free of scale

Scale falling away from the
uncleaned section

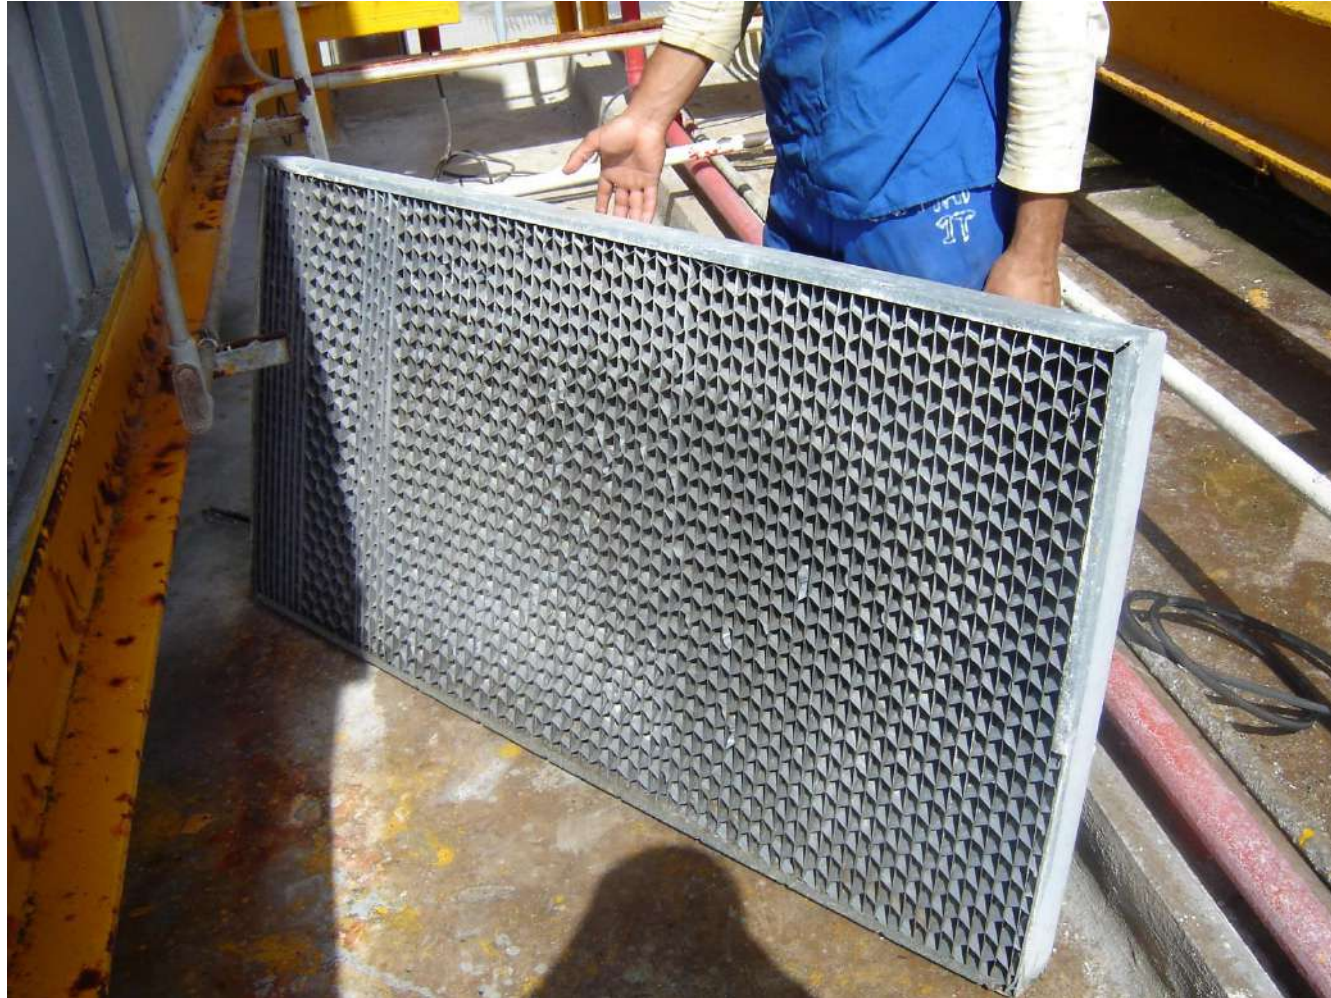
RESULTS DETAIL

Day 62 of Aqua-Rex treatment

Cleaned portion of cooling panel
remains free of scale

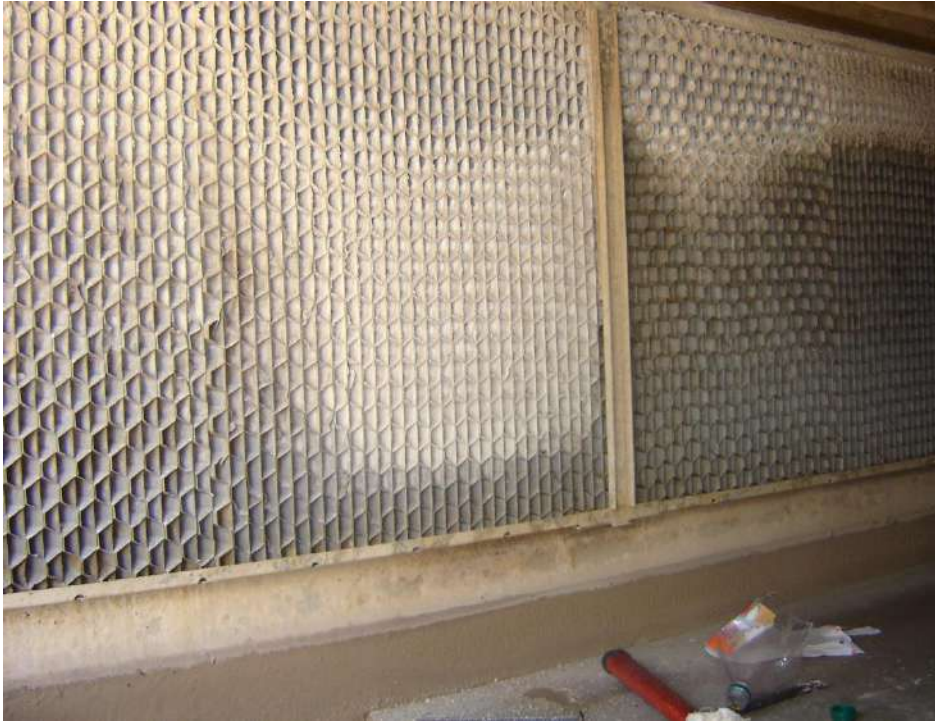
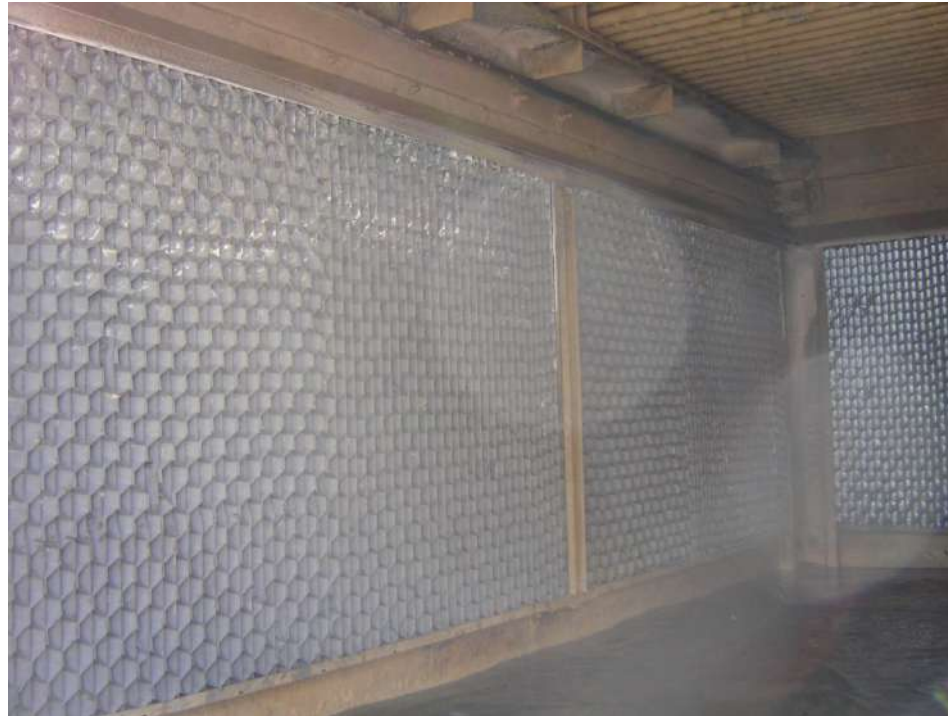
RESULTS DETAIL

Before

Day 62 of Aqua-Rex treatment

After

Cooling panels have less scale

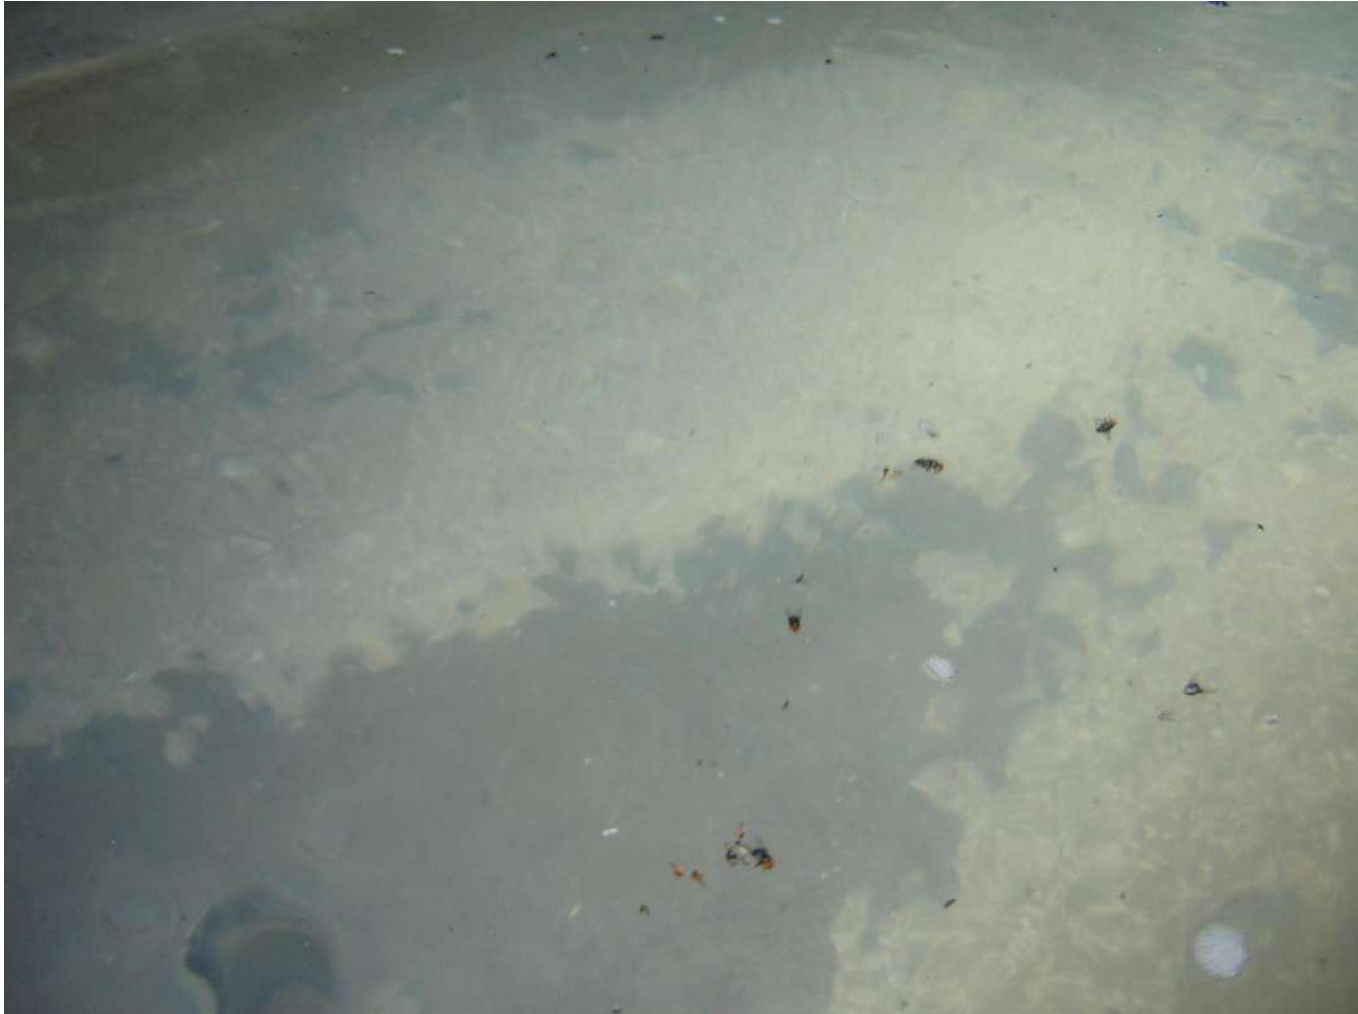
RESULTS DETAIL

Day 62 of Aqua-Rex treatment

Scale particles that have broken off
have settled in the basin
